# Beckfoot Allerton School - Accessibility Action Plan.

Updated: 10/01/2025

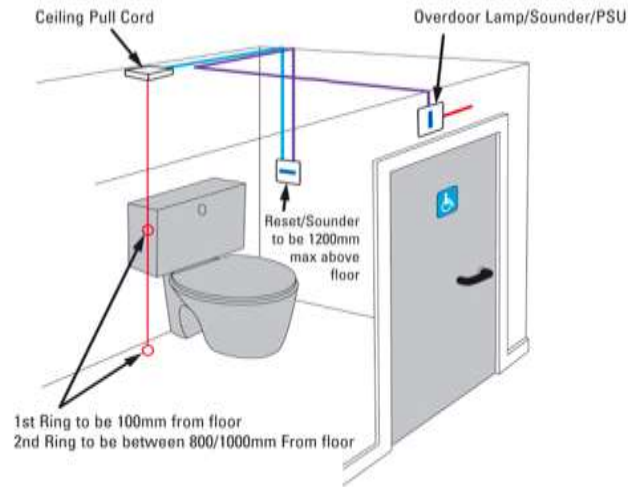
13.11

On the day of the survey, the cord alarm within the accessible WCs were not hanging loose hence should someone stumble on the floor they would not be able to reach it.

Alarm is hanging on opposite side to the WC.

Cord alarms should be provided, and monitored to ensure that they function correctly and are located at full length in their correct position so that they can be accessed in the event of an emergency.

Emergency alarm cords should always feature bangles at two heights and stand at 100mm off the ground floor level. According to BS8300 an emergency assistance pull cord should be sited so that it can be operated from the WC and from an adjacent floor area. The emergency assistance pull cord, coloured red, should be provided with two red bangles of 50 mm diameter, one set at a height between 800 mm and 1000 mm and the other set at 100 mm above floor level.

BS8300 recommends that the reset control for the emergency assistance alarm should be clearly marked as such and should be reachable from a wheelchair and, where relevant, from the WC. The reset control should be easy to operate and located with its bottom edge between 800 mm and 1 000 mm above finished floor level. The marking of the reset control should be both visual and tactile.

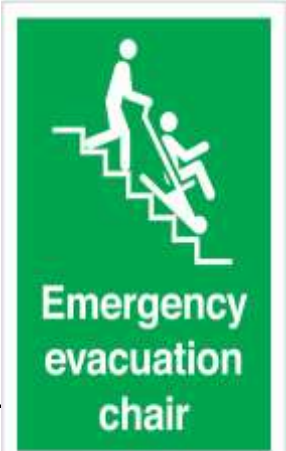
<p>17.5</p>	<p>An evacuation chair was seen in the accessible WC 167.</p> <p>It was not located in the stairwell and had no signs nearby to inform people of its availability.</p> <p>There was a sign seen within one of the upstairs landings but no other signage was seen indicating refuge areas or the evacuation chair.</p>

<p>In order to evacuate disabled people from upper floors suitable equipment should be available within fire refuges. This equipment is often an evacuation chair that requires disabled people to transfer to the evacuation chair before safely descending a protected stairway to a final exit. It is important that the quality of the equipment is high and that there is enough equipment to cater for the expected use of the building by disabled people. <a href="https://directaccessgp.com/evacuation-solutions/">https://directaccessgp.com/evacuation-solutions/</a></p> <p>Signage should be provided to indicate the location of the Evacuation chairs. Depending on where a fire risk assessment identifies the need for a sign, the sign should be displayed prominently, conspicuously and appropriately having regard to the environment and occupancy characteristic of the building.</p>	<p>M</p>	<p>Jul-23</p>

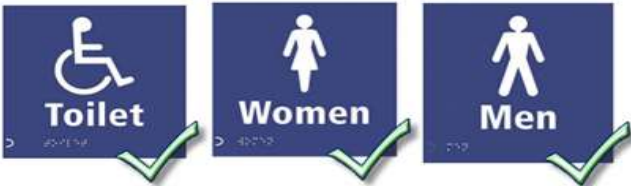
<p>15.3</p>	<p>There is a lack of signage to indicate where the toilets are located, but there is some tactile signage provided on the toilet doors. There was no braille signage.</p> <p>Some WC areas and doors had signs but others such as those in the dining room did not have signs.</p>	<p>The appropriate toilet signage should be provided as part of the recommended way finding review, refer to 15.1. As well as signage on the toilet doors, there should also be signs indicating where the accessible WC is located.</p> <p>BS8300 states - Information and direction signs should be provided at each point where they are required, e.g. at junctions of circulation routes, at key locations such as doorways and reception points, at facilities such as telephones and toilets, and in rooms, spaces and counters. The colour, design and typeface of signs should be consistent throughout a building.</p>

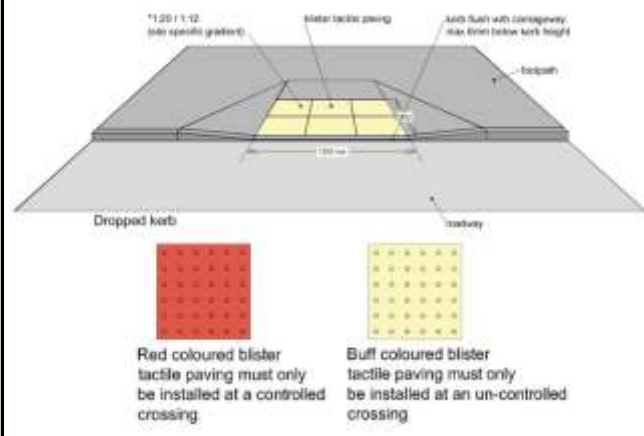
1.2

There is no tactile paving provided to some of the possible crossing points on approach to the site to aid people with impaired vision.

There is no crossing point provided from the carpark to the school entrance.

Depending on the responsible authority (i.e. Bradford Council), contact the Highways Department responsible for the routes on approach to the site, and request to provide tactile paving in areas where there are dropped kerbs to aid people with impaired vision. ADM states that an uncontrolled crossing point across the vehicular route should be identified by a buff coloured blister surface.

Any tactile paving a must be installed correctly and in accordance with Guidance on the use of Tactile Paving Surfaces 2021, See:  
[https://assets.publishing.service.gov.uk/government/uploads/system/uploads/attachment\\_data/file/1046126/guidance-on-the-use-of-tactile-paving-surfaces.pdf](https://assets.publishing.service.gov.uk/government/uploads/system/uploads/attachment_data/file/1046126/guidance-on-the-use-of-tactile-paving-surfaces.pdf)

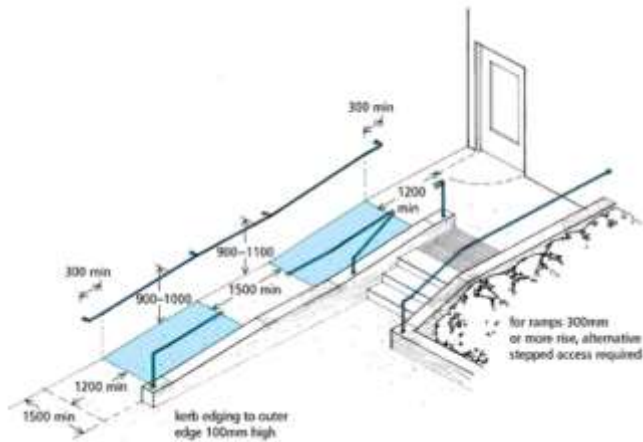
3.2

Most ramps had handrails provided on one side.

Some ramps had black handrails which did not contrast where the walls were darker.

Handrails are a relatively simple and cost-effective adjustment that provides a range of benefits; support, guidance, guarding and route definition. All of these features improve accessibility for disabled people. Implement a rolling programme to upgrade handrails to achieve AD M and BS8300 compliance. Ramps serving communal facilities and access routes used by disabled people should be prioritised with others included as part of any refurbishment or alteration works in future.

ADM vol-2 requires handrails on both sides. BS8300 compliant handrails should be installed to both sides of a ramp. The handrails should be coated with nylon or a suitable alternative to ensure that they are not cold to touch. The handrails should provide the required 300mm horizontal landing extensions with the entire handrail located at a height of 900-1000mm from the slope and landing surface as required by BS8300 and ADM vol-2.

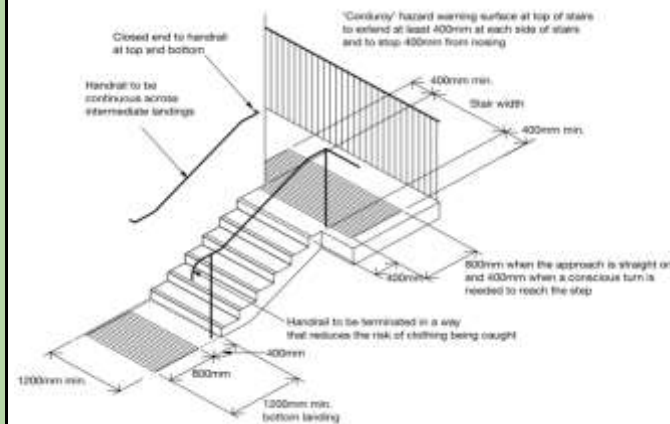
4.1

The following external steps do not feature tactile paving to assist people with impaired vision.

Main Entrance Steps

Entrance area 56

MUPA

Tactile paving is an important hazard indicator for blind and partially sighted people and is expected to be present. Implement a rolling programme to install tactile hazard warning paving to the top and bottom of steps where two or more steps are present. Steps serving communal facilities and access routes used by disabled people should be prioritised with others included as part of any refurbishment or alteration works in future. ADM vol-2 requires a corduroy hazard warning surface provided at the top and bottom of each flight of 800mm x 1200mm minimum, 400mm from the step.

BS8300 - To give advance warning of a step, tactile paving with a corduroy hazard warning surface should be provided at the top and bottom of each flight, excluding intermediate landings with continuous handrails. Where the approach to the stair is wider than the flight, the tactile surface should extend beyond the line of each edge of the flight.

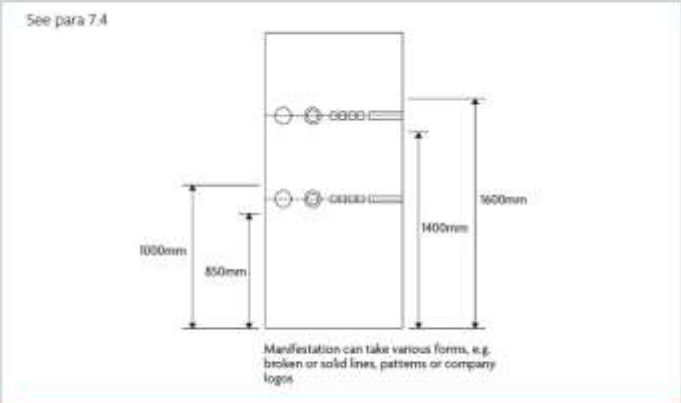
<p>5.9</p>	<p>Manifestations are provided but may not be apparent against the backgrounds seen.</p>	<p>Well contrasted manifestations should be provided at two heights to the entrance.</p> <p>☐</p> <p>Glazed doors need to have permanent strips on the glass within two zones, from 850mm to 1000mm from the floor and from 1400mm to 1600mm from the floor. These strips need to be contrast in colour (not treated glass) and luminance with the background seen through the glass in all light conditions.</p>

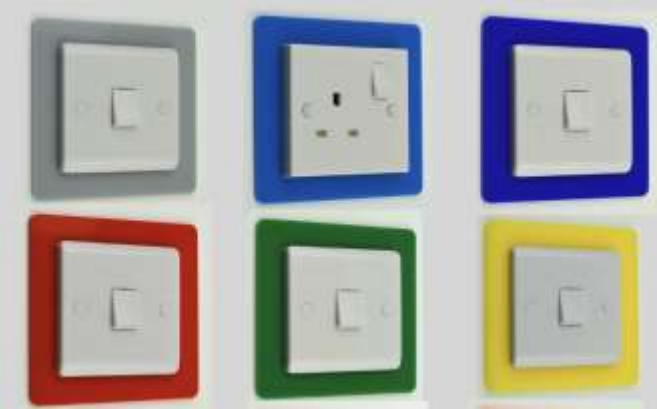
<p>16.2</p>	<p>The majority of the light switch plates are not suitably colour contrasted against their background.</p> <p>Some are also located high for a wheelchair user or a person of short stature at over 1200mm from floor level.</p>

<p>At the next refurbishment for the sites, it would be beneficial to change the existing light switch plates with alternatives that have a grey/silver plate.</p> <p>Alternatively, light switch plates with a contrasting surround could be used.</p> <p>This will ensure that they are easily located by people with impaired vision.</p>	<p><b>M</b></p>	
<p>16.4</p>	<p>There were wall lights seen in one stairwell which can cause glare.</p>	<p>Each flight and landing of a stepped access route should be well illuminated, providing a clear distinction between each step and riser. The illuminance at tread level should be at least 100 lux.</p> <p>Lighting that causes glare (such as poorly located wall lights, spotlights, floodlights or low-level light sources) should be avoided.</p>	<p><b>M</b></p>
