Allerton Accessibility Action Plan April 2023

1.1 - 2	ACTION	TABLE	
---------	--------	-------	--

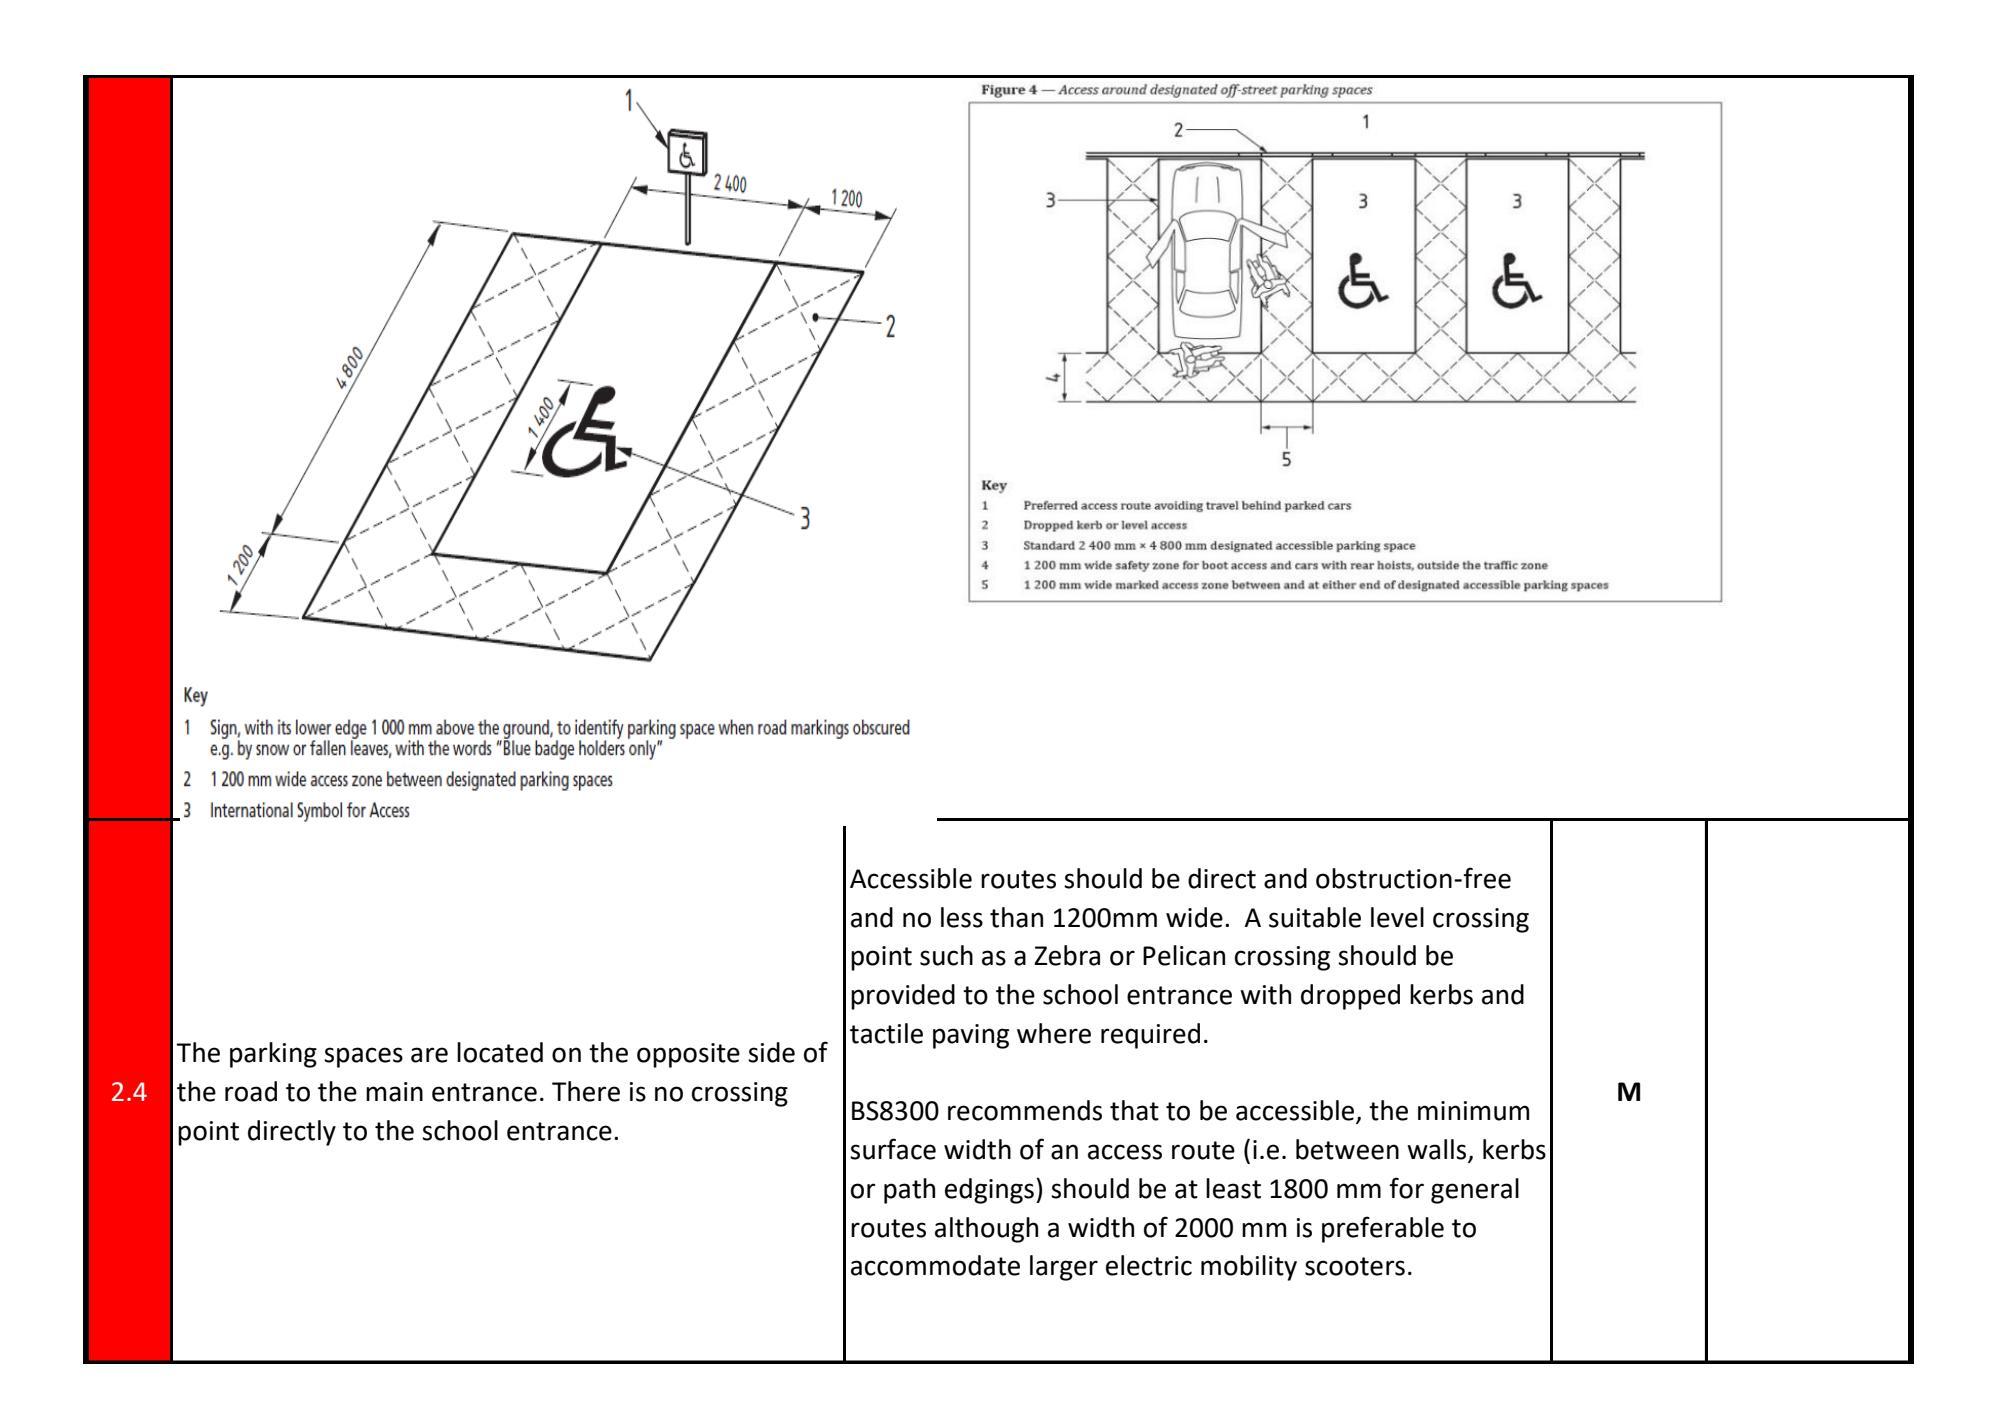
COS	rs - N = NONE M = MINIMAL OG = ONGOING N	IAINTENANCE ST = STRUCTURAL CHANGE EX = MAJ	OR STRUCT	URAL CHANGE
Item Ref.	Details / Issue	Recommendation	Est Cost	Action Taken
PRIOR	ITY A			
2.3	Accessible bays are not of an appropriate size and do not have any recommended markings. The designated accessible parking should be clearly marked out at least 2.4m wide x 4.8m long plus a 1.2m side transfer zone at the side and end of the bay.	The accessible bay markings should provide clearly defined 1200mm transfer zones to both sides and rear and with the required access symbol. BS8300 recommends a sign or, if appropriate, signs should be provided at the entrance to each car park and at each change in direction to direct disabled motorists to designated parking spaces. Also, install a sign to the front of each space as shown:	Σ

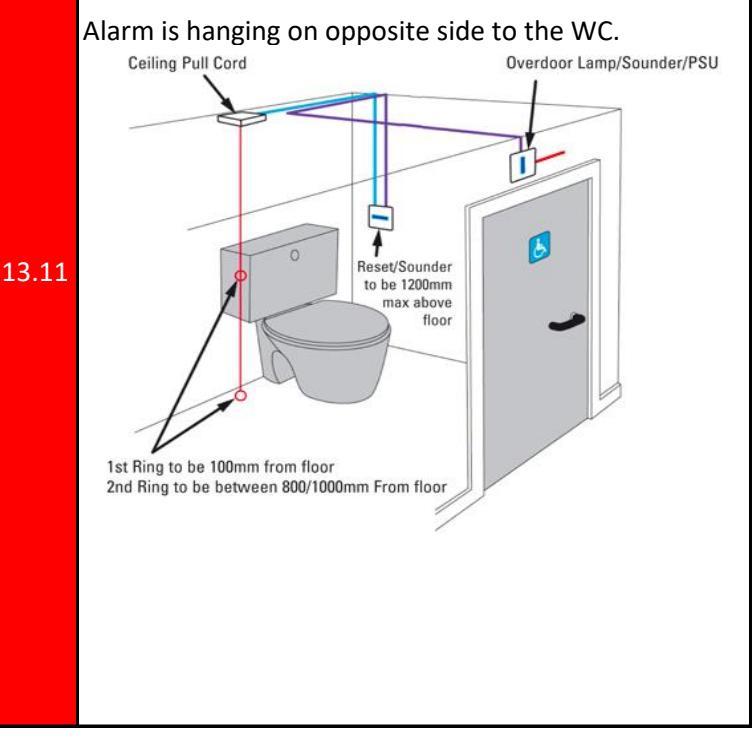
On the day of the survey, the cord alarm within the accessible WCs were not hanging loose hence should someone stumble on the floor they would not be able to reach it.

Cord alarms should be provided, and monitored to ensure that they function correctly and are located at full length in their correct position so that they can be accessed in the event of an emergency.

Emergency alarm cords should always feature bangles at two heights and stand at 100mm off the ground floor level. According to BS8300 an emergency assistance pull cord should be sited so that it can be operated from the WC and from an adjacent floor area. The emergency assistance pull cord, coloured red, should be provided with two red bangles of 50 mm diameter, one set at a height between 800 mm and 1000 mm and the other set at 100 mm above floor level.

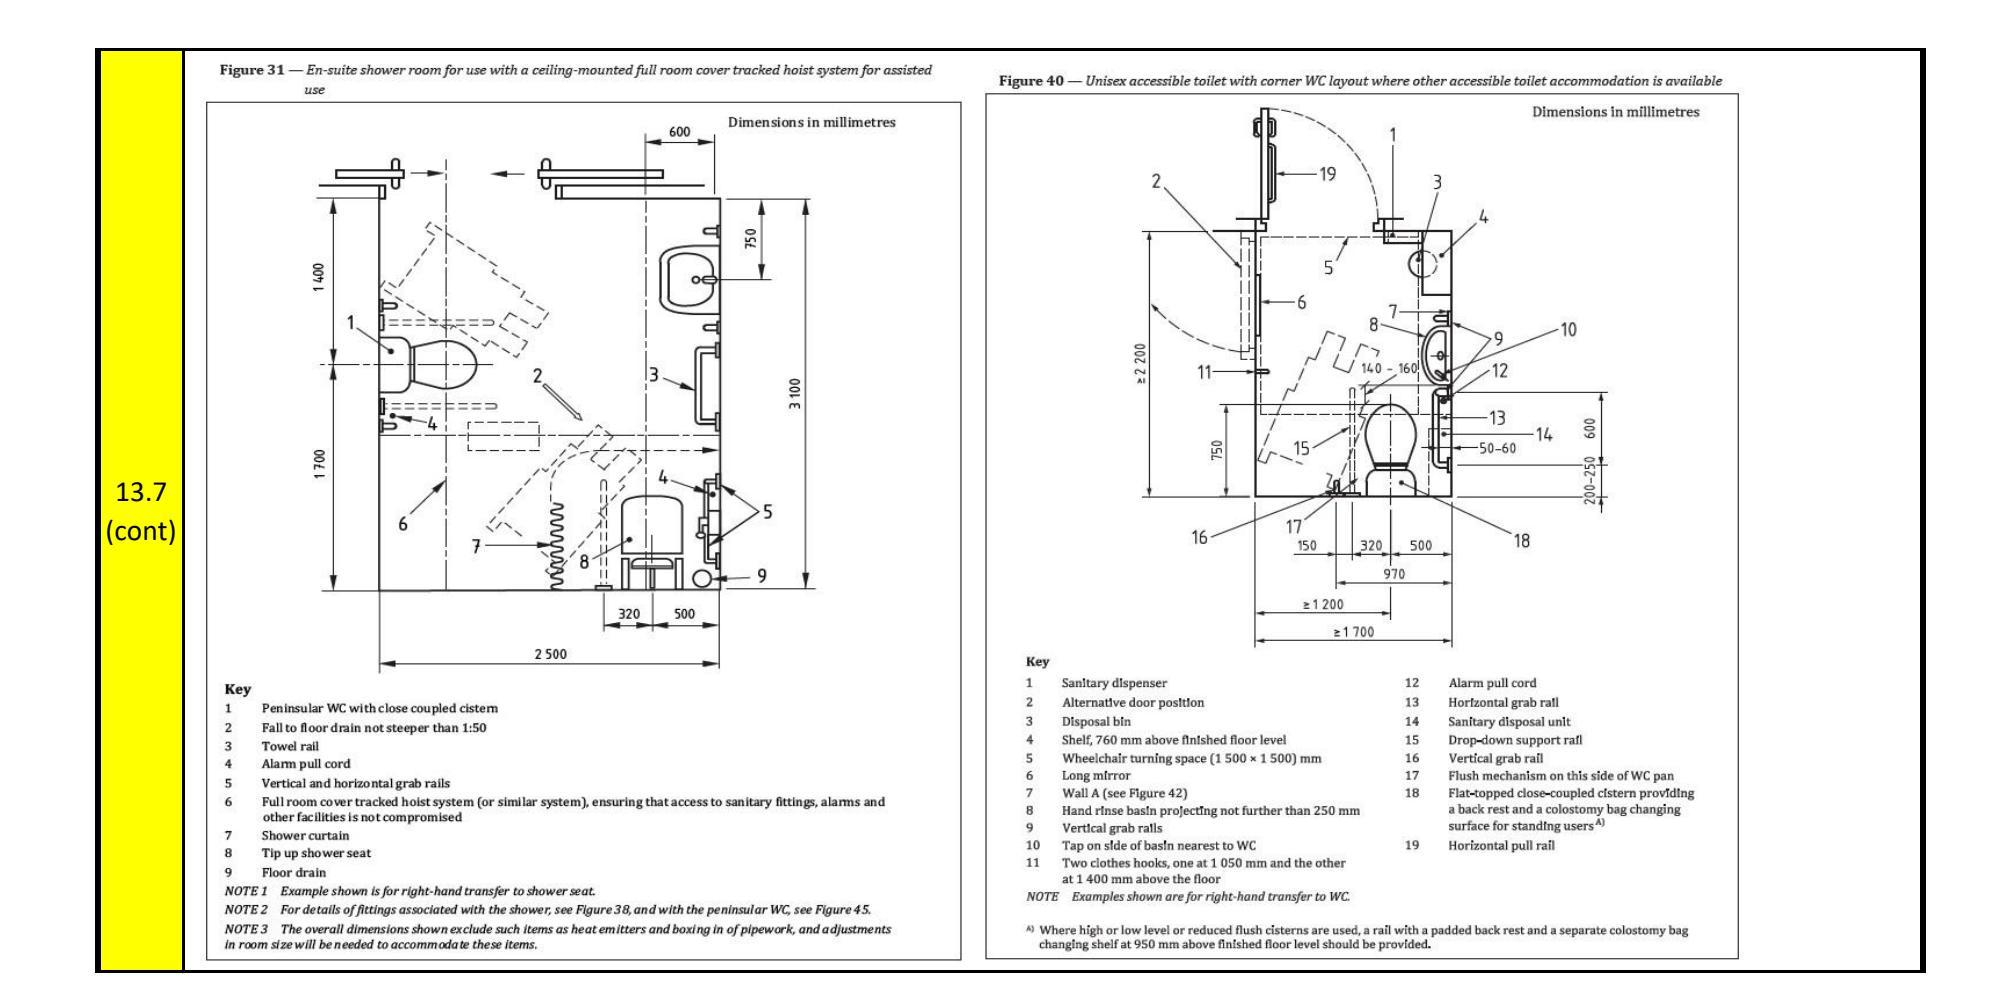
WC 57 was missing the horizontal and drop down grab rails to the right of the WC pan. Some are located near to the shower and obstructed by the shower curtain and don't seem part of the WC fittings. Grab rails did contrast however.	A full BS8300 compliant set of grab rails should be provided where required, appropriate to the layout of the WC provided. Refer to the images below for locations of		
13.7		the required grab rails.	M/OG	
	WC 37 is not currently used as an accessible WC, being			
	used as the girls changing area for the Nursery. It still	Ensure any installed fixtures and fittings contrast from the		
	has the signage however. it does not have the required	surrounding surfaces.		
	grab rails if it were to be used as an accessible WC in			
	future.

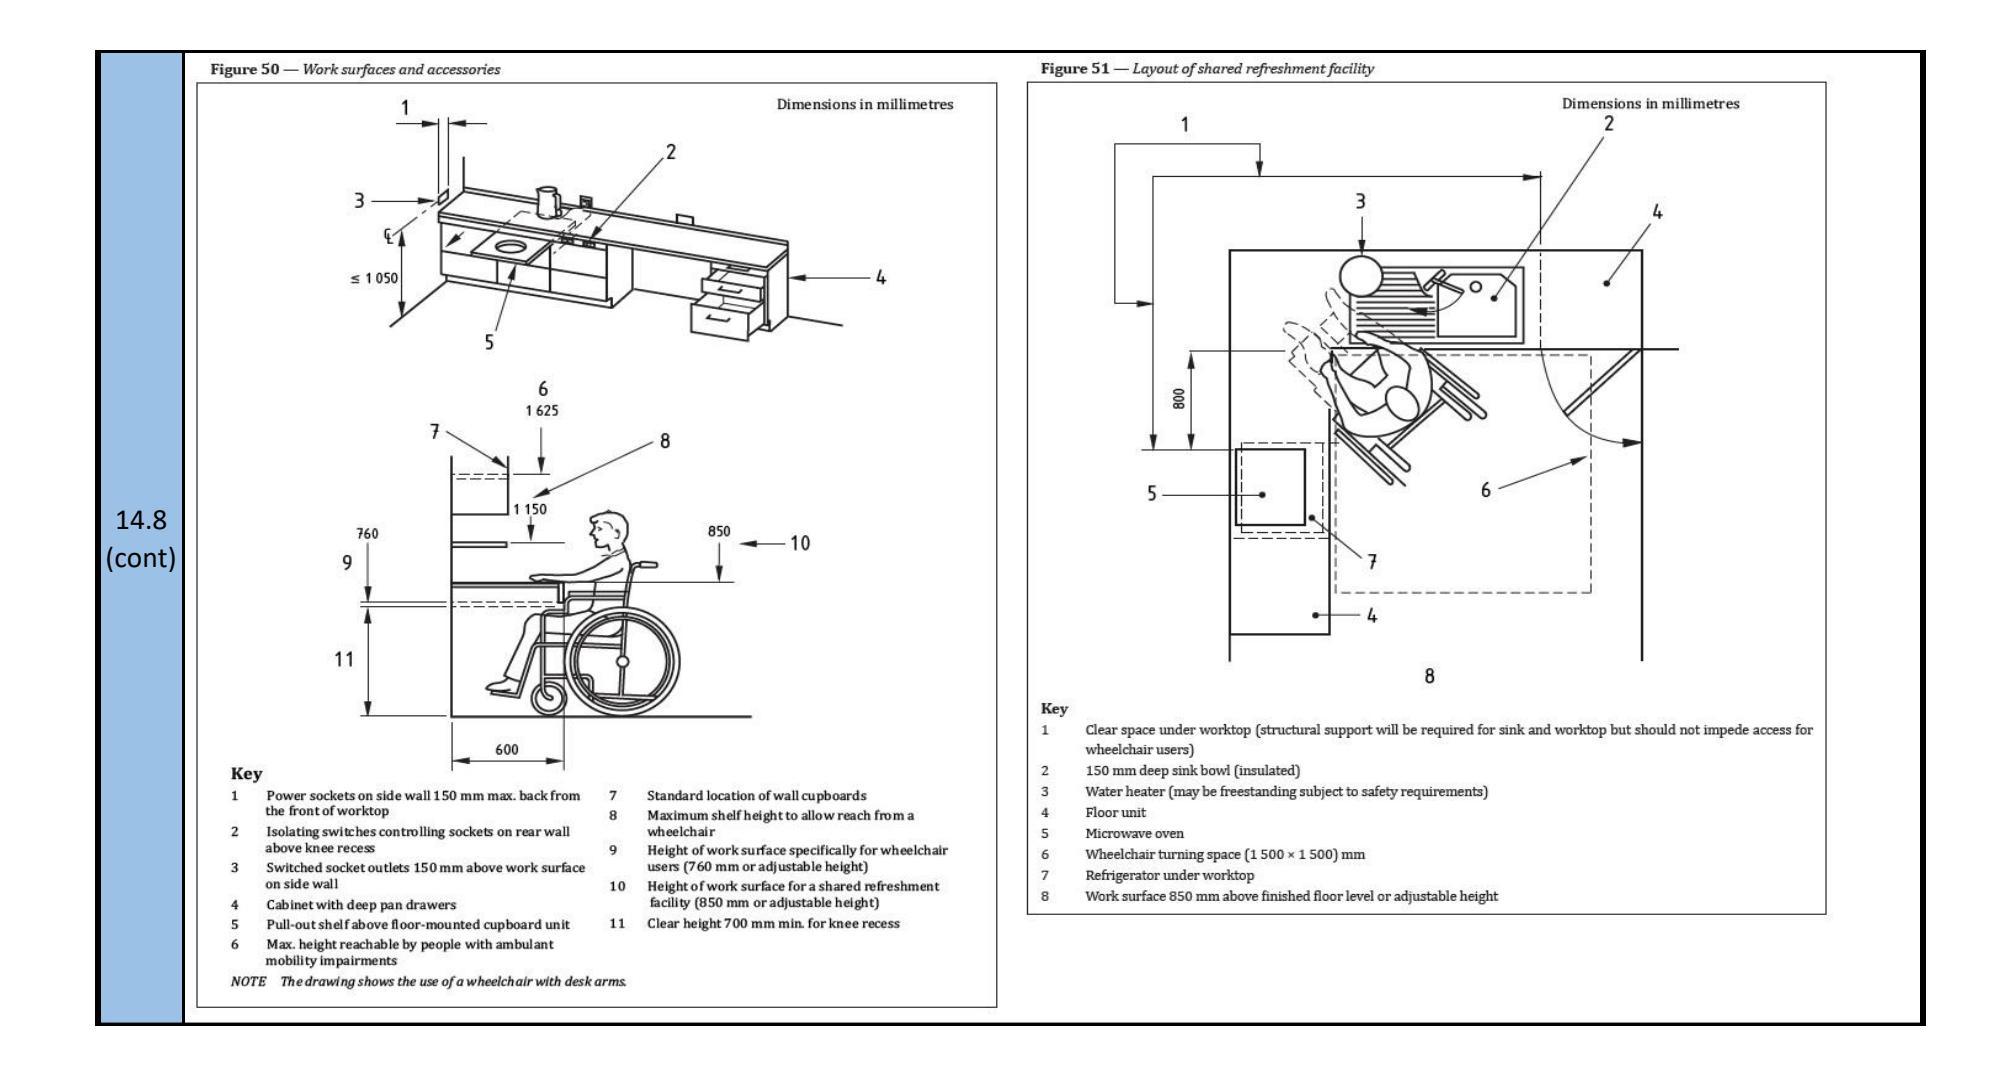
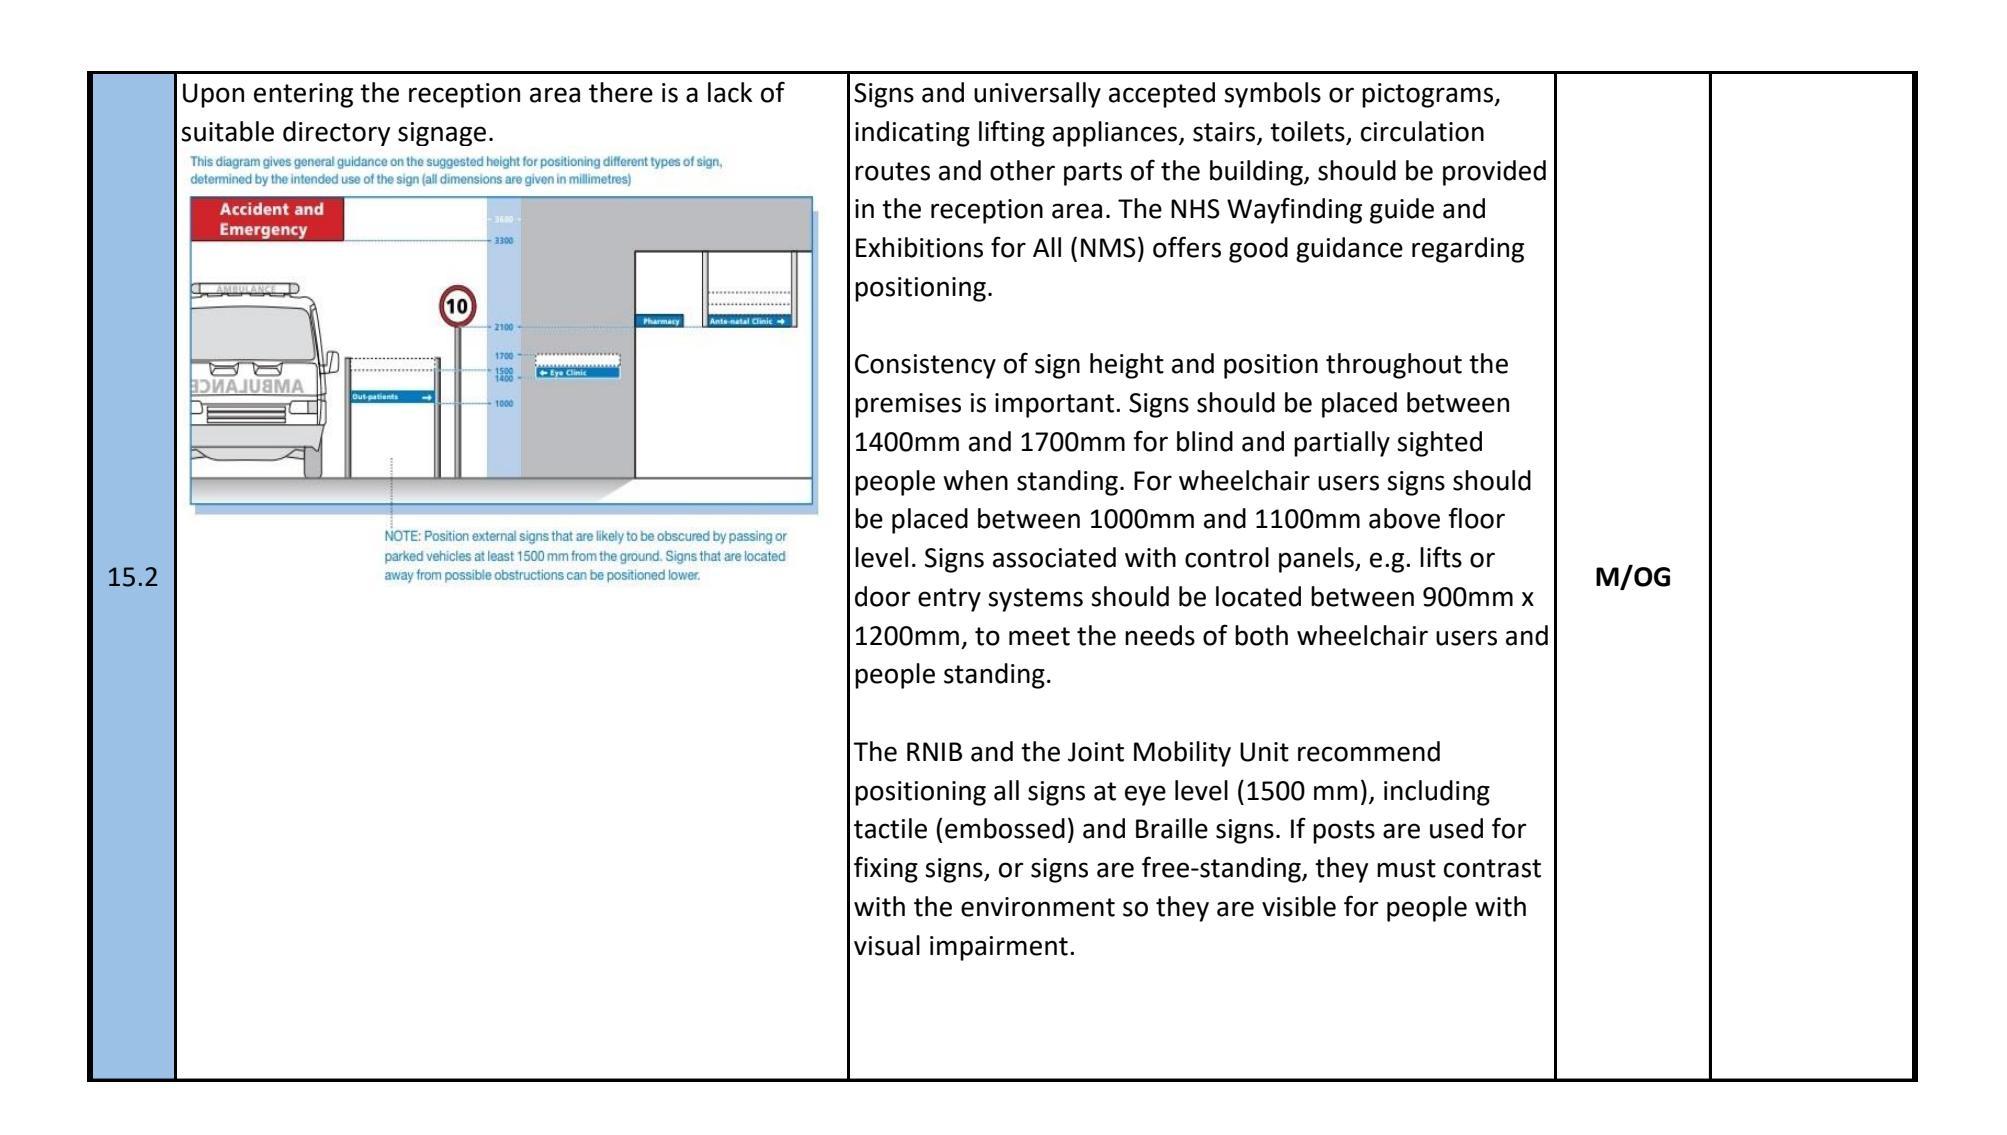
Staff kitchenettes in rooms 9, 34 No lever taps are provided. Main staff room 77 has lever taps.	A kitchen area should have an unobstructed floor space of at least 1 500 mm × 1 500 mm between facing floor units or between floor units and a wall. Where possible, an unobstructed space or knee recess, at least 800 mm wide, should be provided to one side of kitchen appliances such as refrigerators, washing machines, freezers or ovens.		
14.8		taps to aid people with limited dexterity.	M/ST	
	No lowered counters are provided.			
	EYFS classroom area has lowered counters with lever taps provided.	The kitchenettes should include disability access, i.e., a section of work top lowered to 760mm (or 850 for a shared worksurface) with clear space underneath of minimum 700mm to allow wheelchair access; sink unit to have lever taps fitted, and utensils included. Refer to images.
