# Beckfoot Allerton School - Accessibility Action Plan.

Updated: 10/01/2025

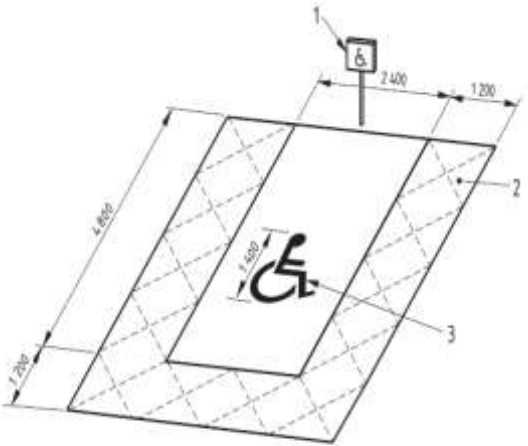
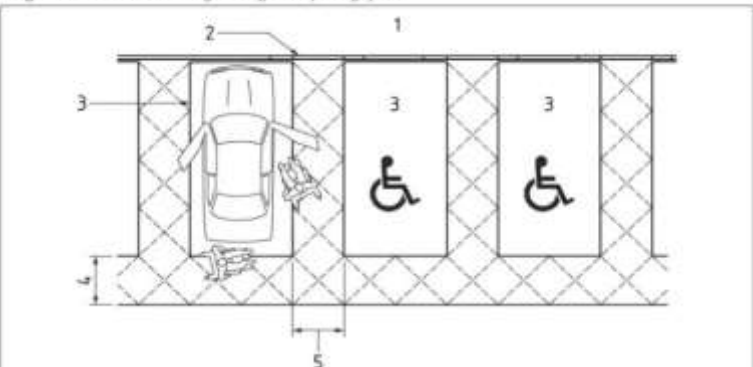
Item Ref.	Details / Issue	Recommendation	Est Cost	Action Taken
2.3	<p>Accessible bays are not of an appropriate size and do not have any recommended markings.</p> <p>The designated accessible parking should be clearly marked out at least 2.4m wide x 4.8m long plus a 1.2m side transfer zone at the side and end of the bay.</p>	<p>The accessible bay markings should provide clearly defined 1200mm transfer zones to both sides and rear and with the required access symbol.</p> <p>BS8300 recommends a sign or, if appropriate, signs should be provided at the entrance to each car park and at each change in direction to direct disabled motorists to designated parking spaces. Also, install a sign to the front of each space as shown:</p>	M	May-24

<p><b>Key</b></p> <ol style="list-style-type: none"> <li>1 Sign, with its lower edge 1 000 mm above the ground, to identify parking space when road markings obscured e.g. by snow or fallen leaves, with the words "Blue badge holders only"</li> <li>2 1 200 mm wide access zone between designated parking spaces</li> <li>3 International Symbol for Access</li> </ol>	<p><b>Figure 4 — Access around designated off-street parking spaces</b></p>

<p><b>Key</b></p> <ol style="list-style-type: none"> <li>1 Preferred access route avoiding travel behind parked cars</li> <li>2 Dropped kerb or level access</li> <li>3 Standard 2 400 mm x 4 000 mm designated accessible parking space</li> <li>4 1 200 mm wide safety zone for hoist access and cars with rear hoists, outside the traffic zone</li> <li>5 1 200 mm wide marked access zone between and at either end of designated accessible parking spaces</li> </ol>

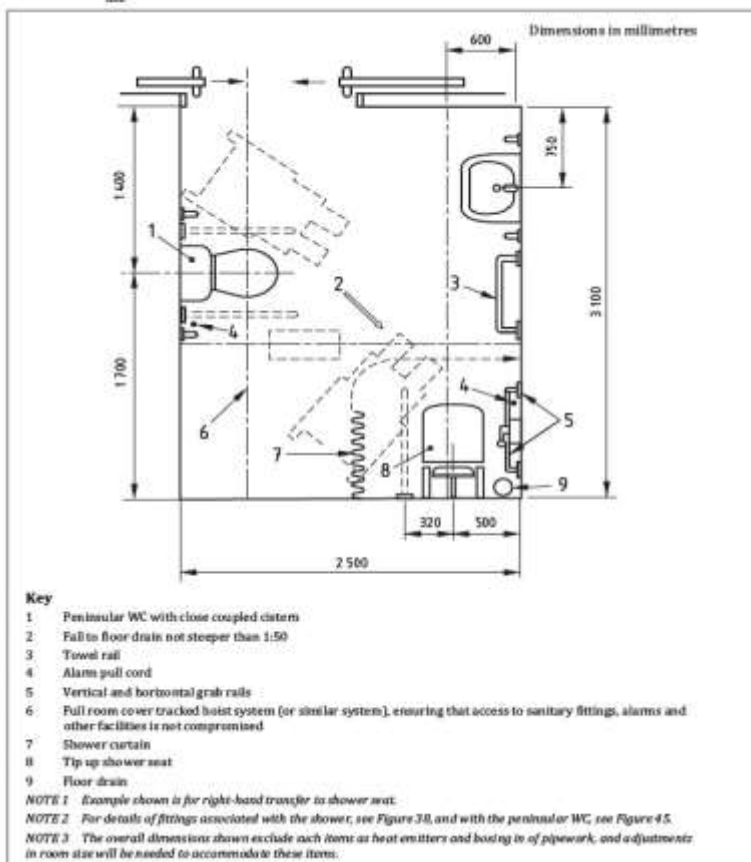
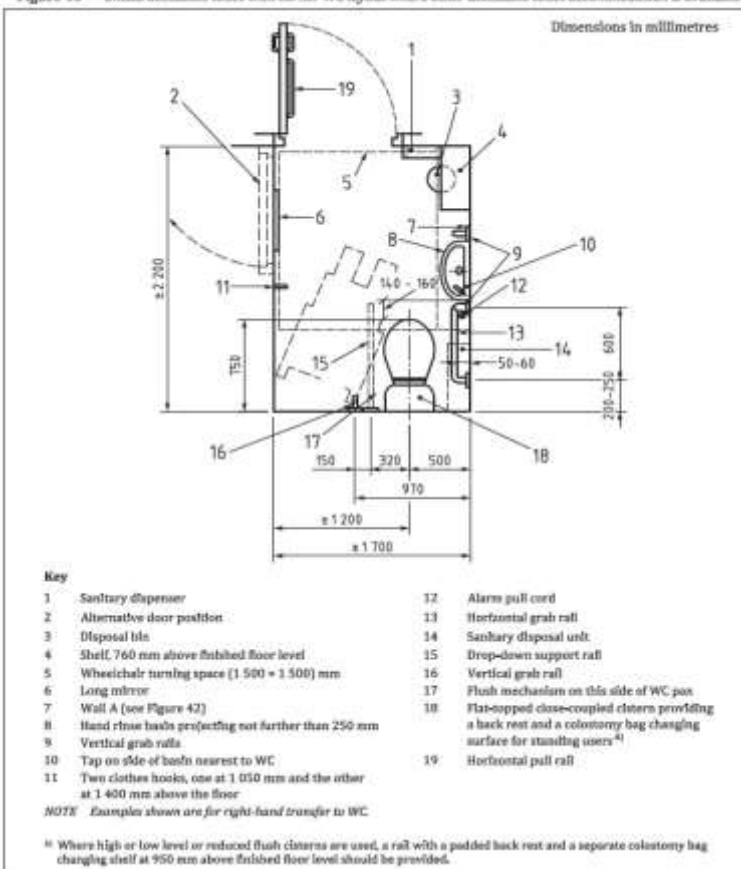
13.7	<p>WC 57 was missing the horizontal and drop down grab rails to the right of the WC pan. Some are located near to the shower and obstructed by the shower curtain and don't seem part of the WC fittings. Grab rails did contrast however.</p> <p>WC 37 is not currently used as an accessible WC, being used as the girls changing area for the Nursery. It still has the signage however. it does not have the required grab rails if it were to be used as an accessible WC in future.</p>	<p>A full BS8300 compliant set of grab rails should be provided where required, appropriate to the layout of the WC provided. Refer to the images below for locations of the required grab rails.</p> <p>Ensure any installed fixtures and fittings contrast from the surrounding surfaces.</p>	<b>M/OG</b>	
------	---	---	-------------	--

Figure 31 — *In-suite shower room for use with a ceiling-mounted full room cover tracked hoist system for assisted use*

Figure 40 — *Unisex accessible toilet with carrier WC layout where other accessible toilet accommodation is available*

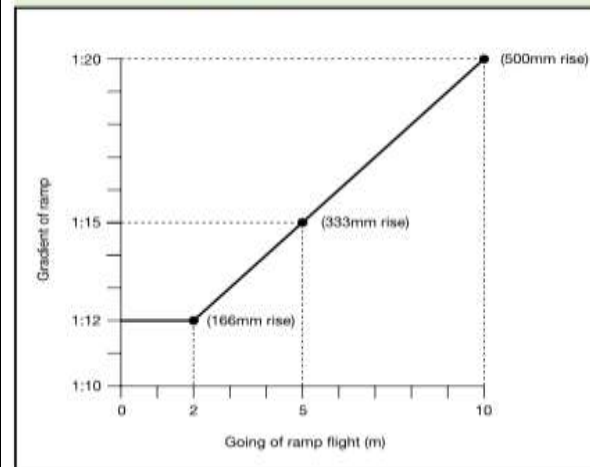
**Diagram 3 Relationship of ramp gradient to the going of a flight**

Some of the current access route ramps are of a gradient steeper than that deemed reasonable under ADM. Where possible, during any future works, the gradients of these primary access routes should be reduced to provide an ADM compliant ramp gradient as below:
